Manhole Inspection Summary

Manhole # S13II2012MH

Insp Date: **6/30/06 1:59 PM**

Location Address: **2108 NORTHCLIFF DR**

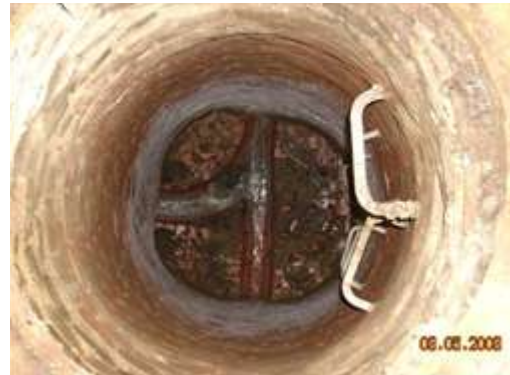
Top View

Evidence of surcharge - Bench debris.
Channel debris.

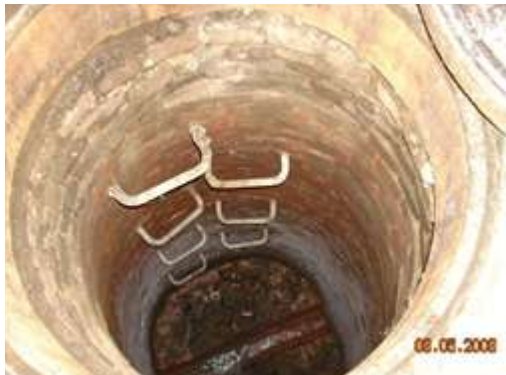
Defect

Frame leaks. Frame offset. Adjustment
and Corbel deterioration and infiltration.
Barrel infiltration.

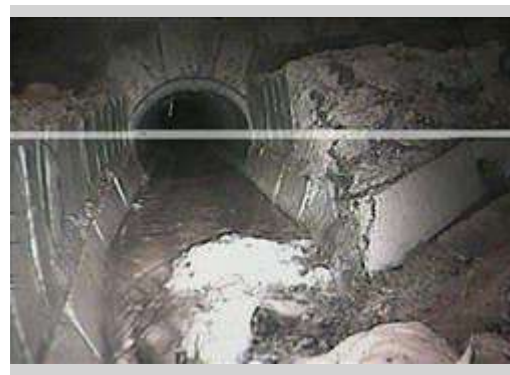
Defect

Channel deterioration and debris.

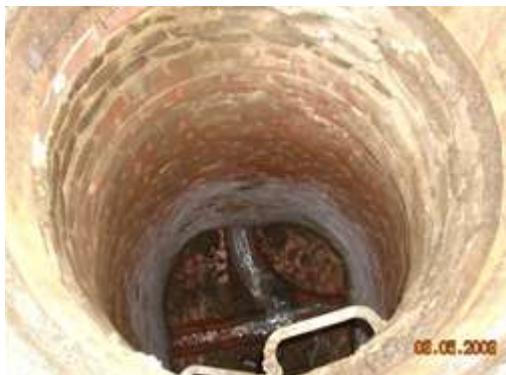
Defect

Frame leaks. Frame offset. Adjustment
and Corbel deterioration and infiltration.
Barrel infiltration - other side.

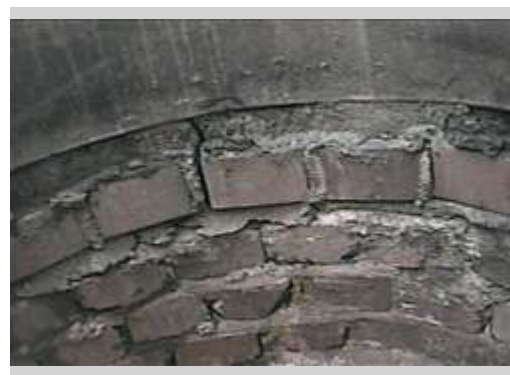
Defect

Frame leaks. Adjustment and Corbel
deterioration and infiltration.

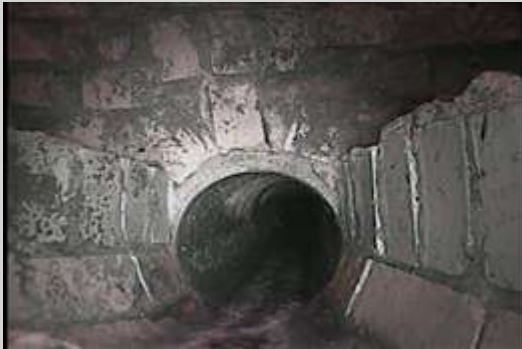
8 in. Circular Gravity Sewer Pipe Out @ 12 O'Clock

Deposits: ☐ None ☒ **Mud** ☐ Sludge ☒ **Debris** ☐ Grease

Silt Depth: **0** (in.) Deposits Extent: **Light**

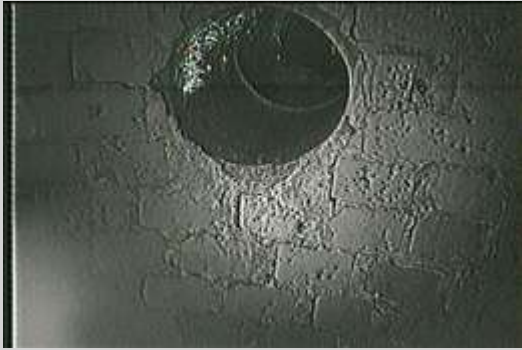
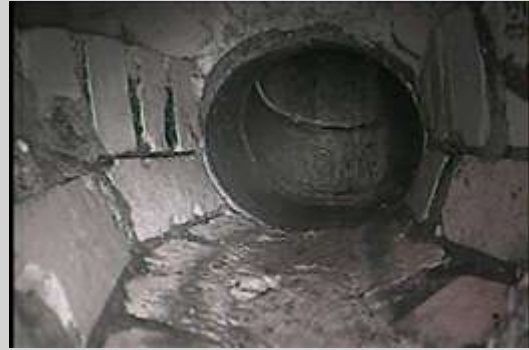
Drop In @ 9 O'Clock

Infiltration: **Evidence** Pipe Seal Cond: **Unknown**

Drop: **Outside** Rod and Bar

Drop Condition: **Open**
